# Fatigue Crack Growth in a Unidirectional SCS-6/Ti-15-3 Composite

Prepared for the  
Third Symposium on Composite Materials: Fatigue and Fracture  
sponsored by the American Society for Testing Materials  
Orlando, Florida, November 6-9, 1989

## Abstract

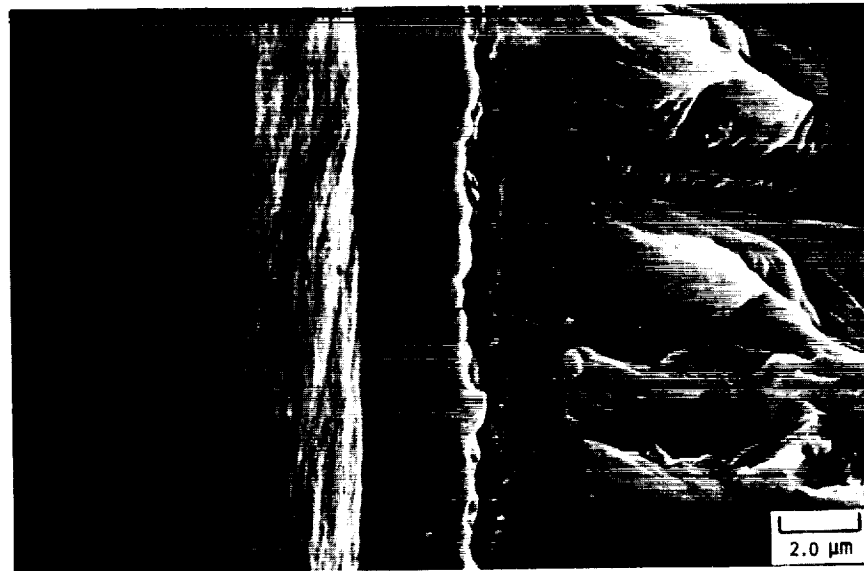
FIGURE 14. - SEPARATION OF CARBON COATING FROM THE FIBER IN  $[90]_g$  CT SPECIMEN. IN THE CENTER OF THE FRACTOGRAPH NOTE A CRACK BETWEEN CARBON COATING AND THE INTERFACE.

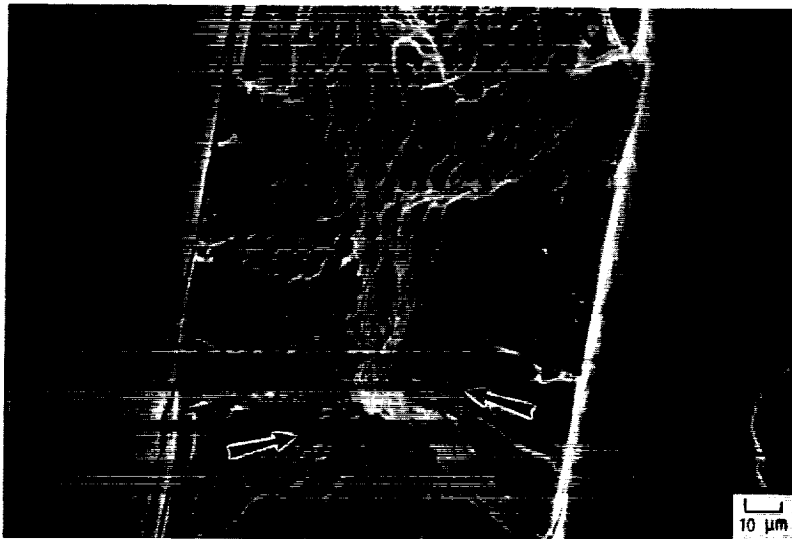
(a) LOW  $da/dN$ .

(b) HIGH  $da/dN$ .

FIGURE 15. - MICROSCOPIC CRACK GROWTH FROM THE INTERFACE INTO THE MATRIX LIGAMENTS IN THE  $[90]_8$  SPECIMENS.
